# Energy Assessment Report

## Whitemarsh Township Municipal Building

616 Germantown Pike, Lafayette Hill, PA 19444

August 2013

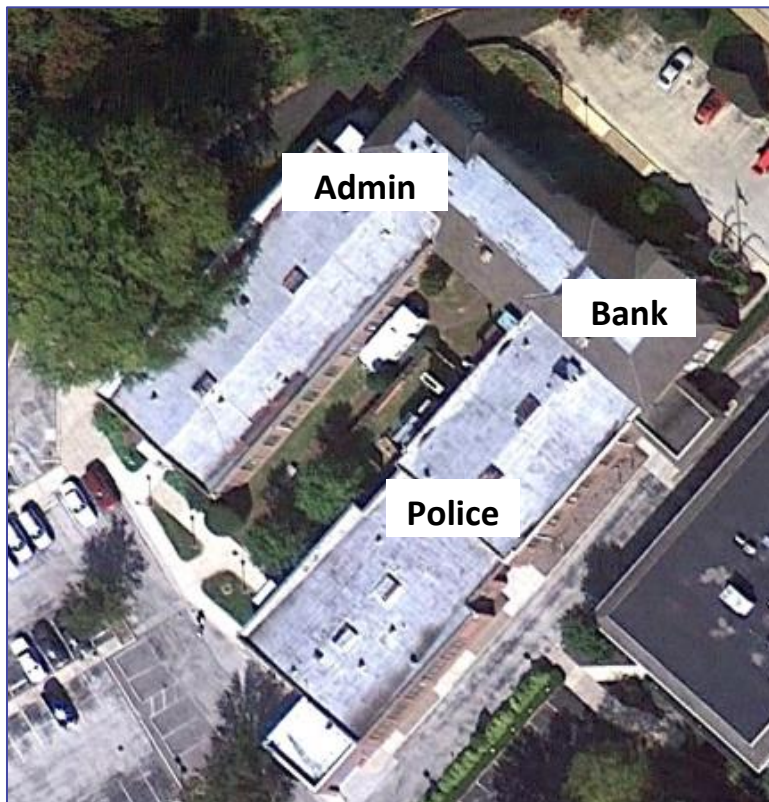
Figure 1: Whitemarsh Township Building, Aerial View (© 2013 Google Earth)

The Whitemarsh Township municipal building (approx. 21,500 ft<sup>2</sup>) comprises administrative offices, council meeting rooms, and a police department; a bank occupies the northeast corner of the facility and was not included in this assessment (see Figure 1 below). The brick masonry building is at least 80 years old and has undergone several renovations in its history. Whitemarsh Township moved into the building in the 1980s and performed extensive renovations including the current HVAC system.

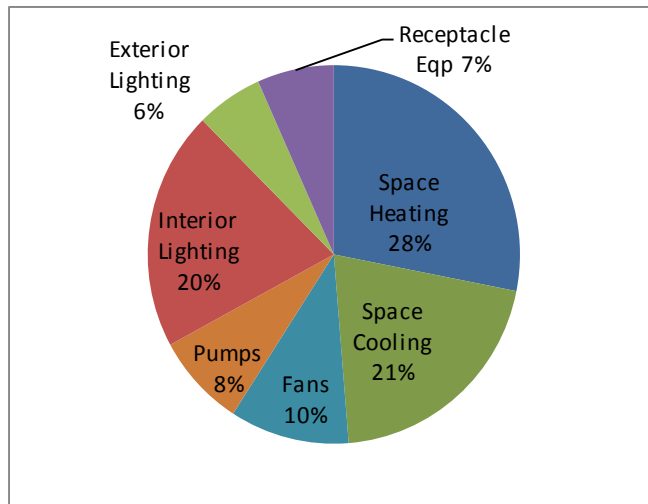
Figure 5: Electricity End-Uses<sup>1</sup>

To determine the best opportunities for energy savings, it is important to understand how the various building systems consume energy. PES developed a breakdown of energy “end-uses” (i.e., lighting, HVAC, etc.) based on historical utility consumption and our site walkthrough. Figure 5 and Figure 6 show the percentage of total utility consumption for the major electric and natural gas end uses.

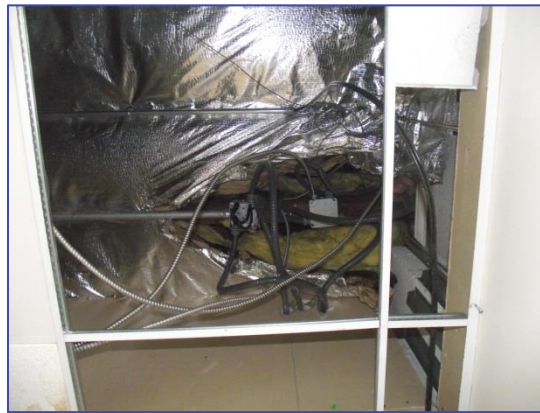
The roof has both flat and pitched sections. The flat sections of the existing roof (approx. 19,371 ft<sup>2</sup>) are in poor condition and in need of replacement. The existing roof likely has no more than 1/2" of rigid insulation above the roof deck, and interior foil-faced batt insulation adhered to the ceiling appears to have significant water damage in many areas (Figure 7). Moisture can compress the batt insulation and inhibit insulation performance; this can also promote mold growth on neighboring surfaces. Whitmarsh Township has already issued a bid specification for replacing the flat roof sections, and this is critical to prevent further leaks.

**Figure 7: Ceiling Leak in Lobby of Police Area**

The bid specification issued for the roof replacement includes a new EPDM membrane roof and 1/2" of polyisocyanurate (polyiso) above-deck rigid insulation (R-2.5), with an option to increase the insulation thickness to 3" (R-19). PES strongly urges that the approved project include at least 3" of above-deck polyiso insulation to meet the minimum energy code.<sup>5</sup> This will likely increase the project cost by approximately \$20,000 and pay back in approximately 12 years due to increased energy savings (Table 5). Table shows the estimated relative energy savings and cost premium between the bid-specified 1/2" polyiso and the recommended 3" polyiso, as well as a high-efficiency option of 3-1/2" polyiso, which would further increase the roof insulation performance to approximately R-25.<sup>6</sup>

We also recommend removal of the existing ceiling-adhered batt insulation. With 3" of polyiso insulation, the batt insulation will no longer be needed. In addition, the insulating value of the batt is likely already compromised due to moisture, and mold/deterioration issues could occur if this wet insulation is left in place.

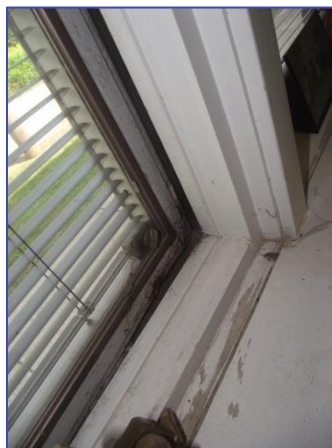
Windows in the office and police areas are double-paned, wood-framed units with internal metal shades; many of the frames are in poor condition or have been patched recently (Figure 8). These windows should be considered for replacement due to their age, poor frame condition, and poor thermal performance.

**Figure 8: Window with Frame Damage**

Window replacements and insulated shade installation are both unlikely to be cost-effective from an energy savings perspective, and are therefore not discussed further in this report. However, these measures can improve occupant comfort and, when replacements are necessary due to age or condition, energy-efficiency should be part of the selection criteria.
